Welcome to our Featured Home Event:

A Spa-Like Master Bathroom

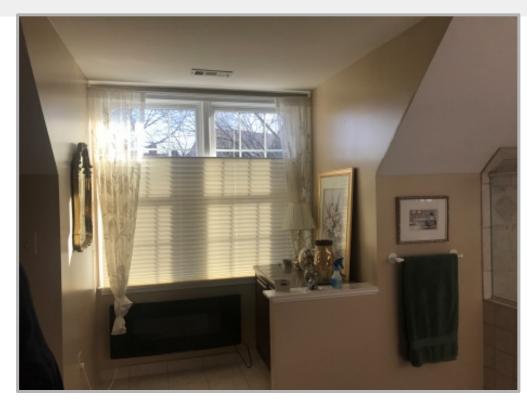
Repurposed Fireplace

We took the existing fireplace from an awkward position beneath the windows (and in danger of the curtains) and moved it to the lower level, across from the soaking tub.

We surrounded the fireplace in stone to create a spa-like feel.

To address heating issues, the **electric fireplace** was relocated from below the double windows to the bathtub area, and **new heating components** were added to the upper and lower tier, including a **toe kick heater** beneath the vanity.

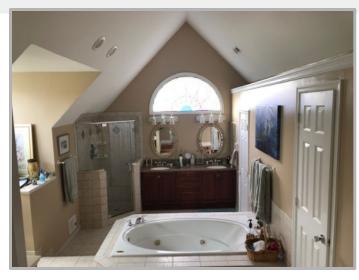
Repurposed Vanity

The clients loved their vanity, so we reused the same vanity cabinet and moved it to the upper level to create a focal point.

The design of the floating mirrors, which also contain medicine cabinets, was a feat of engineering. It took superior craftsmanship to create the sturdy steel support system, while maintaining the symmetry, see-through option the clients wanted, enhanced beauty and functionality.

The creative solution was to "float" the mirrors. We created an H-shaped custom metal tube frame to add rigidity and support the weight of the medicine cabinets. Lighting wiring was hidden inside the tube frames.

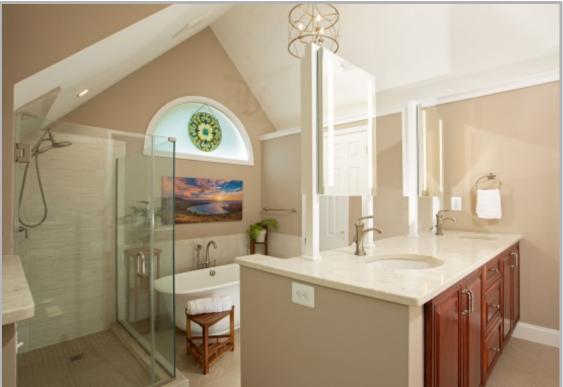
Two-Level Reconfiguration

Working on two levels proved a challenge. The master bathroom had to be carefully designed to incorporate steps as well as placement of electrical wiring and water supplies.

We redesigned and reconfigured the entire master bath, with the exception of the commode area. The toilet remained in the same location.

The results was a "dry" area in the upper level, with the commode and sinks, and a "wet" area in the lower level, with the tub shower, and fireplace.

We had to go in through the garage ceiling to access pipes, and installed an upgraded electrical box in the garage that can also be used in the future to charge an electric car!

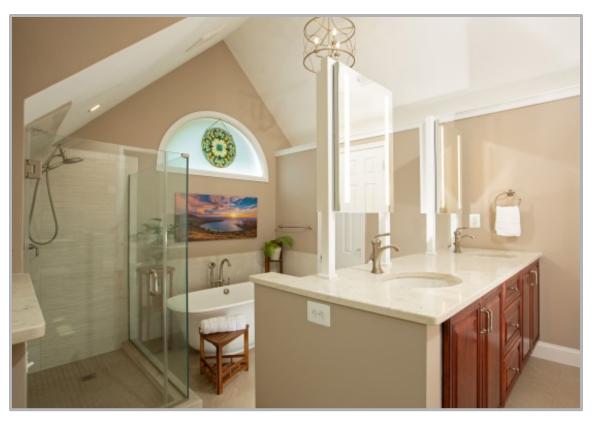
Supporting Floating Mirrors

The clients wanted mirrors and medicine cabinets above the sinks, with integrated lighting.

The biggest challenge was how to install these without obstructing the sightline from the master bedroom, and to be able to see around and under the mirrors.

The wall behind the vanity was reinforced, and hidden behind drywall and the stone finish surrounding the fireplace.

Because the support tubes were in one piece, and the ceiling clearance was an obstacle, determining the mirror height and inserting the posts into the countertop were huge challenges.

We had to slide the H-frame down, template the countertop with the metal posts so we knew how to build the countertop, take the posts out, have the countertop fabricated, fit in the counters, and re-slide the posts in.

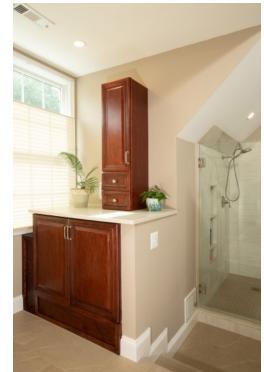
There was an existing cabinet beneath the double windows on the upper level that had no purpose. This was redesignated for the European laundry.

The dimensional depth of the existing cabinet was not quite large enough for the washer/dryer appliance, but since the clients loved their cabinets and wanted to keep them, we disassembled the cabinet, enlarged it, added the appliance and laundry pan, and rebuilt the cabinet. The alterations are unnoticeable.

An upper cabinet was added, and a new, larger countertop was added to blend with the sink countertop.
